End-winding vibration monitoring for hydro-generators

S. GIROUX
Rio Tinto Alcan
Canada

A. TÉTREAULT
VibroSystM
Canada

PLANT BACKGROUND

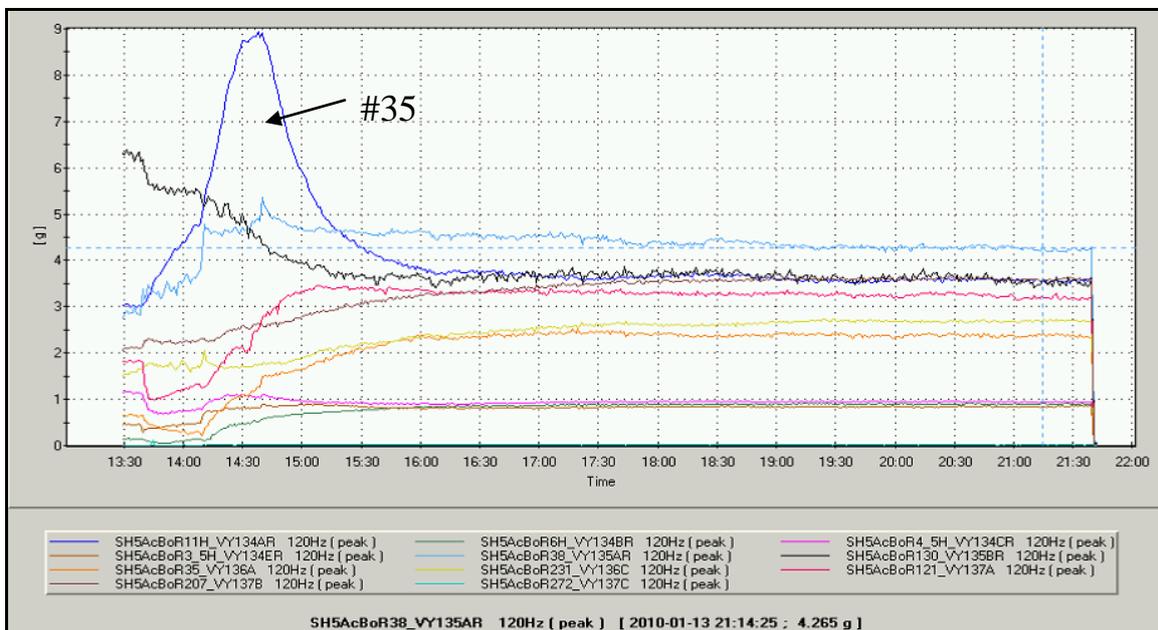
Spectrum analysis of vibration signals revealed that most activity occurred at the electro-magnetic fundamental frequency of 120 Hz. Some coils demonstrated very high vibration activity while the Unit was warming up but the levels significantly decreased as the generator warmed up and reached stabilized temperature. Vibration levels of ~9 g and ~10 g (~310 μm , pk-pk, and ~345 μm , pk-pk, at 120 Hz) were recorded during the temperature rise, but all accelerometers stabilized below 5 g (~175 μm , pk-pk, at 120 Hz) in steady warm operation (See Figures 1, 2 & 3). Meanwhile, accelerometers on the stator core measured radial vibration levels of less than ~0,5 g (~20 μm pk-pk at 120 Hz).

If the Unit is maintained at a load near 70 MW, while operating at nominal temperature, the end-winding vibration levels should not be an issue. However, if the generator is frequently stopped and restarted, the high vibration levels while the Unit is cool could be problematic.

Figure 1. 12-hour trend of end-winding vibration (radial) with a peak of ~9 g (~310 μm , pk-pk, at 120 Hz) for end-winding #35 during the temperature rise. Vibration levels stabilize between ~1 g and ~4 g (~35 μm , pk-pk, to ~140 μm , pk-pk, at 120 Hz) in steady state – hot operating condition.

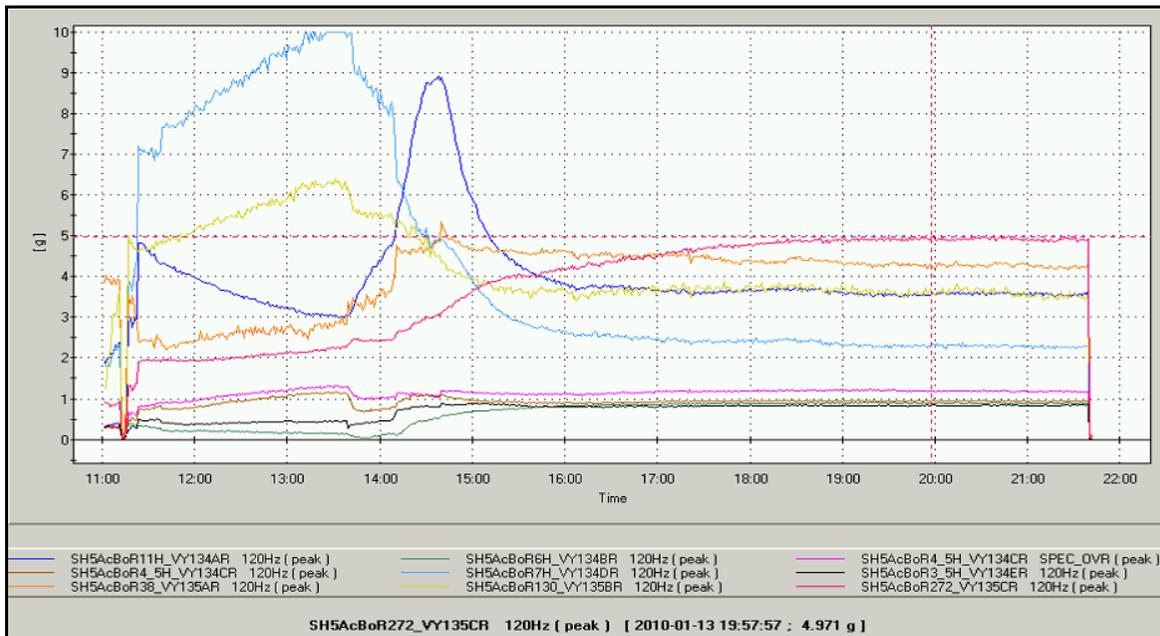
Figure 2. Same trend of radial vibration for the series-connection leads. One coil peaks at ~10 g (~345 μm , pk-pk, at 120 Hz) during the temperature rise, then vibration levels for all coils stabilize below 5 g (170 μm , pk-pk, at 120 Hz).

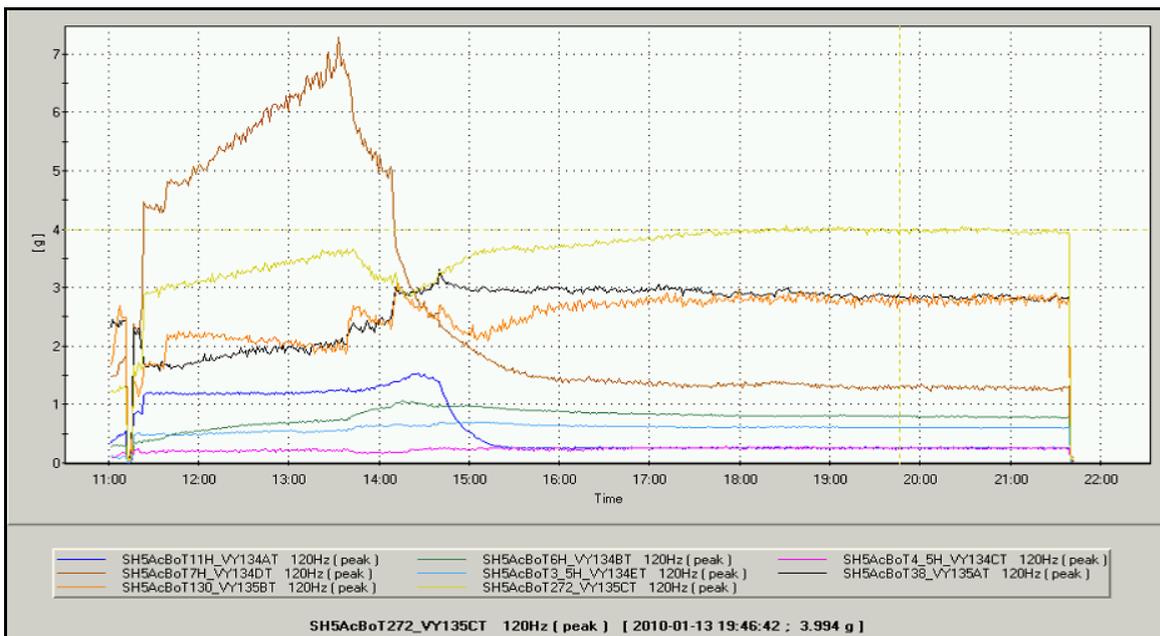
Figure 3. Same trend of tangential vibration for the series-connection leads. Vibration levels peak at ~7,4 g (~255 μm , pk-pk, at 120 Hz) on one coil during the temperature rise, then stabilized below 4 g (140 μm , pk-pk, at 120 Hz).

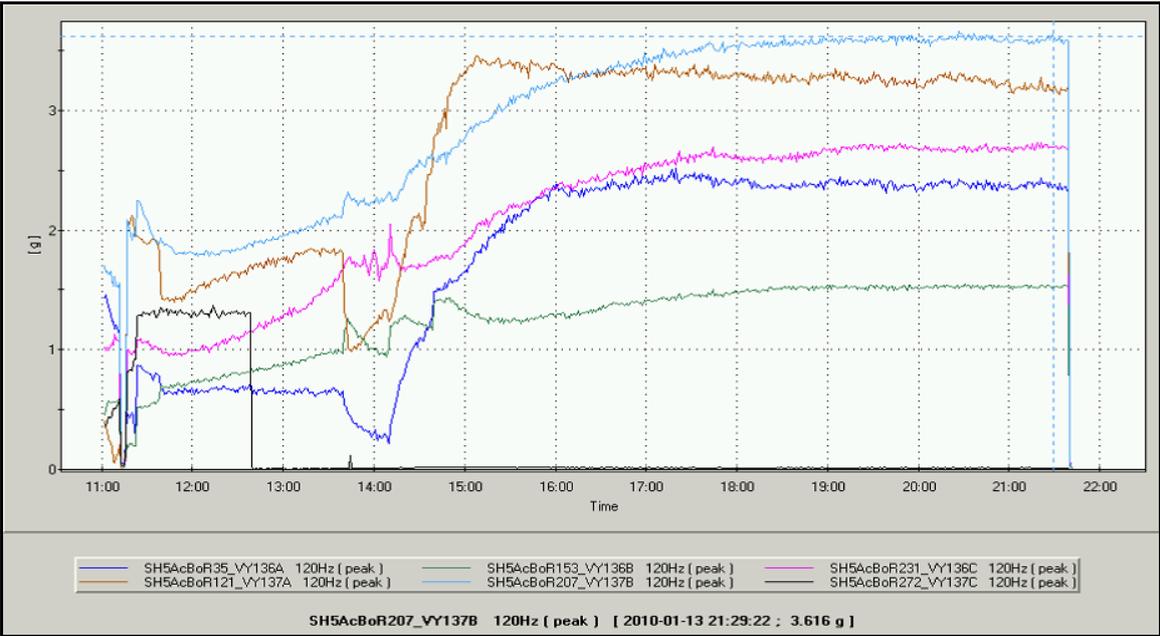
Figure 4. Trend of radial end-winding vibration of the coils with high PD activity. Vibration levels remain below 3.6 g (125 μm, pk-pk, at 120 Hz).

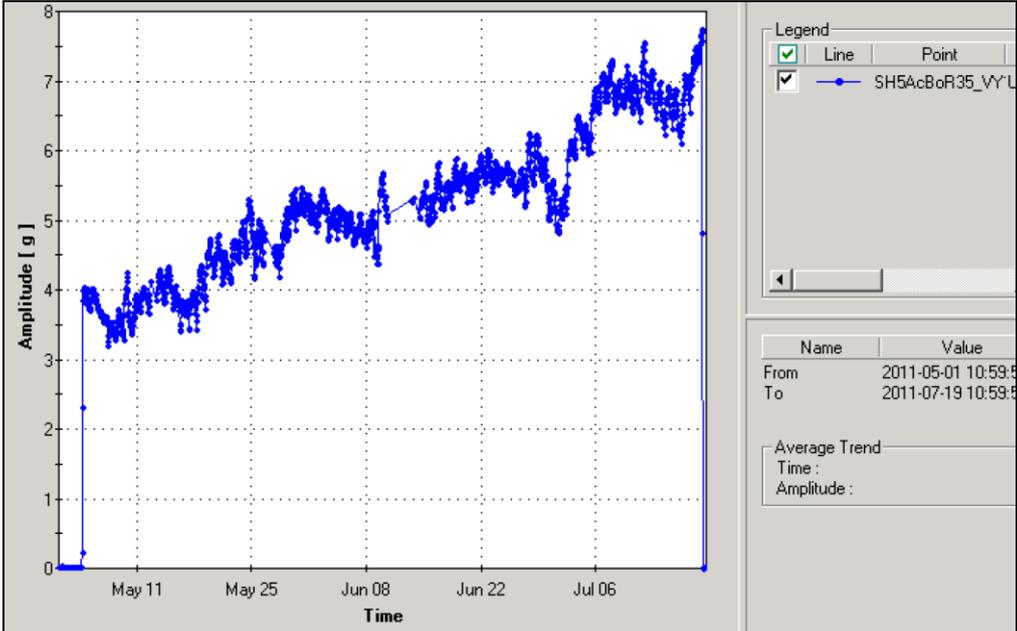
Upon restart of generator no. 5, in May of 2011, the radial vibration levels of end-winding #35 trended upwards, from ~4 g in early May to ~7.5 g at the end of July (~140 μm, pk-pk, to ~260 μm, pk-pk, at 120 Hz) (See Figure 5 below). This result clearly indicated some looseness of the end-windings, specifically at end-winding #35. After interpretation of these results, it was decided to attempt restoring the stiffness of this end-winding using wet ties (Dacron® felt and fibreglass tape impregnated with epoxy) and bracing blocks.

Figure 5. Upward trend of end-winding #35 radial vibration levels from ~4 g in early May to ~7.5 g on July 19th (~140 μm, pk-pk, to ~260 μm, pk-pk, at 120 Hz).

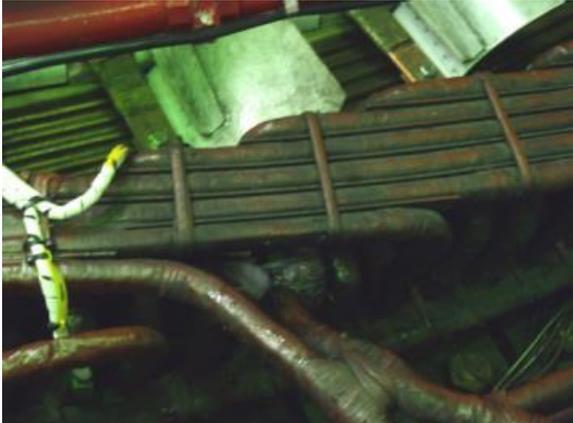
Felt and fibreglass tape behind coil #35.

Another view of the same coil

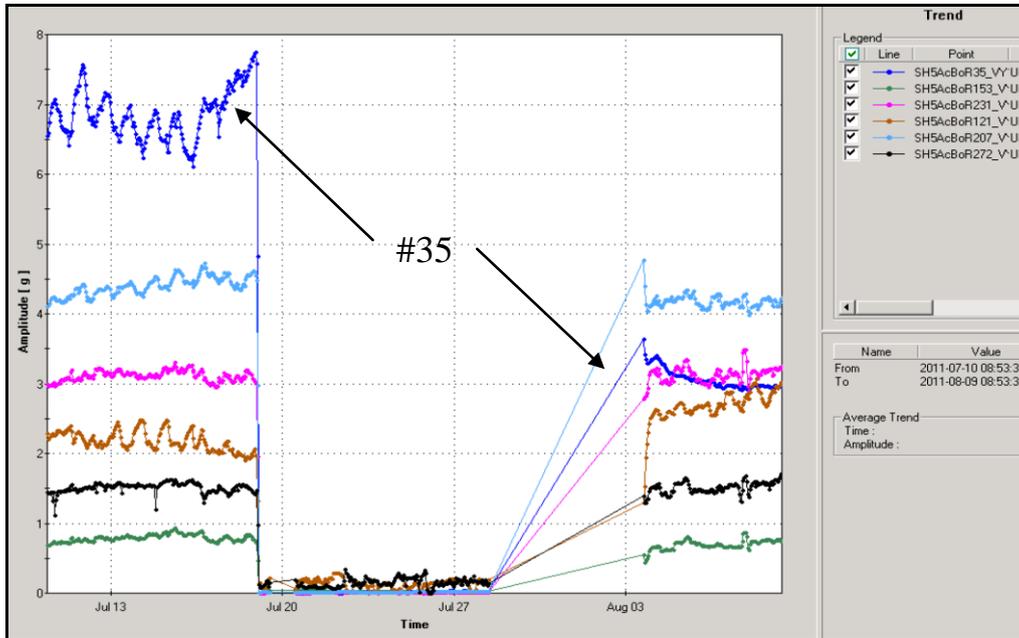
When the Unit was returned to service in early August 2011, a significant reduction of radial vibration levels was immediately observed. The vibration levels decreased from ~ 7.5 g down to ~ 3 g for end-winding #35 (~ 260 μm , pk-pk, to ~ 105 μm , pk-pk, at 120 Hz) (See Figure 6 below).

Figure 6. Trend of radial vibration levels of end-windings before and after the intervention shows a reduction of ~ 4.5 g (~ 155 μm , pk-pk, at 120 Hz) on end-winding #35.

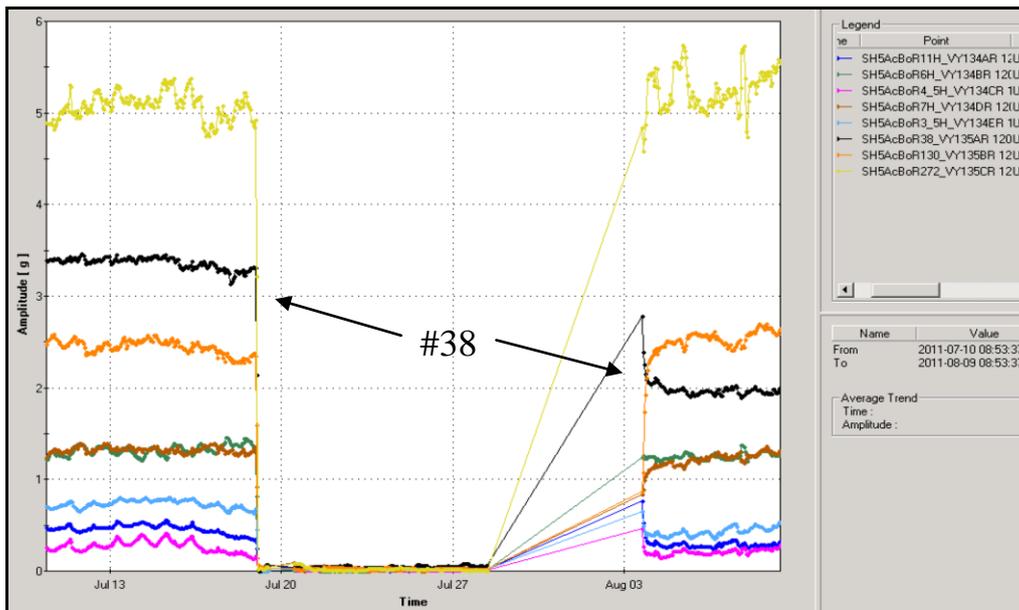
Figure 7. Trend of radial vibration levels of end-windings lead connections for the same period shows improvement of adjacent end-winding vibration levels at end-winding #38 as well.

A positive impact was also observed on adjacent end-winding #38 (lead series-connection); where a noticeable reduction of ~3.4 g down to ~2 g (~115 μm , pk-pk, to ~70 μm , pk-pk, at 120 Hz) was measured in the radial axis and ~3 g to ~1.6 g (~105 μm , pk-pk, to ~55 μm , pk-pk, at 120 Hz) in the tangential axis (*See Figure 7 on the previous page*). All the while, the stator core and stator frame radial vibration levels remained between ~0.25 g and ~0.5 g (~10 μm , pk-pk, and 20 μm , pk-pk, at 120 Hz).
